UTILIZZAZIONE DEI SOLVENTI CLORURATI COME AGENTI DI LAVAGGIO NELL'INDUSTRIA METALMECCANICA ED IN PARTICOLARE NELLA PRODUZIONE DELLE PUNTE IN OTTONE PER ARTICOLI SCRIVENTI

THE USE OF CHLORINATED SOLVENTS AS WASHING AGENTS IN THE METAL AND STEEL INDUSTRIES, AND PARTICULARLY IN THE PRODUCTION OF BRASS POINTS FOR WRITING INSTRUMENTS, WITH ASSOCIATED PROBLEMS

Massimo Gippa  
Pietro Buzzetti

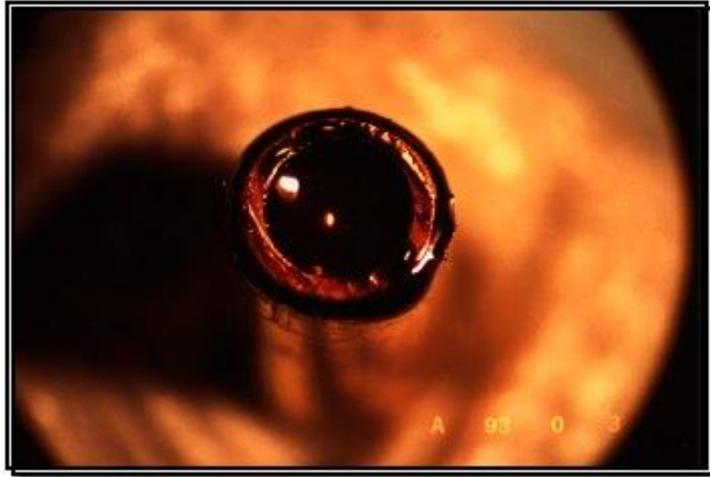
*Fotografia nr.1*

The latter observed at the microscope always appeared perfectly clean and free from any oxidation (see picture n. 1).

*Tip removed from a defective refill in the shoulder area.*

*The tip ink is clear and pure without any sign of crystallisation. Moreover the tip crown shows no corrosion etching, meaning that ink did not etch the brass.*

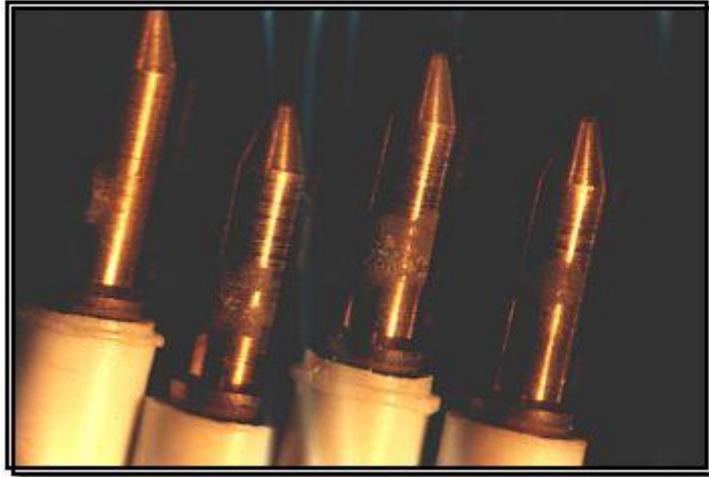
*Fotografia nr.2*

Moreover, tips showed a corroded area on their outer wall as it can easily be observed in pictures n. 2 and 3.

*Defective refills show a wide ring-like corrosion area in the tip outer wall.*

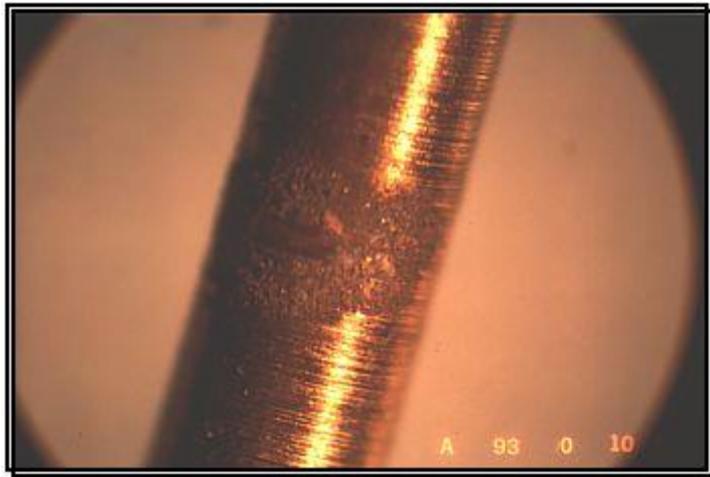
*Fotografia nr.3*

*Observation of one of the tips already shown in Picture n. 2, with a greater magnification. Please note the saline efflorescence (very evident here) due to a brass selective oxidation with the consequent formation of salts of the three main metals making up the alloy.*

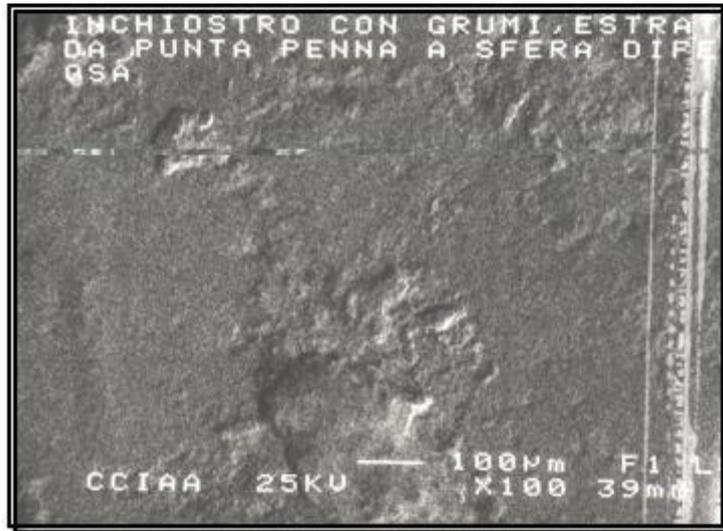
*Fotografia nr.4*

The EDS analysis, as it can be easily observed (Chart n. 2 and Picture n. 18), highlighted as basic elements agglomerates of copper with zinc and chlorine. Their arrangement perfectly overlaps with that of the clot removed from the tip (see Picture n. 4).

*Examination of the waxy clot found in the ink of a defective refill tip.*

*Please note the different crystalline structure of the two profiles compared with the surroundings material.*

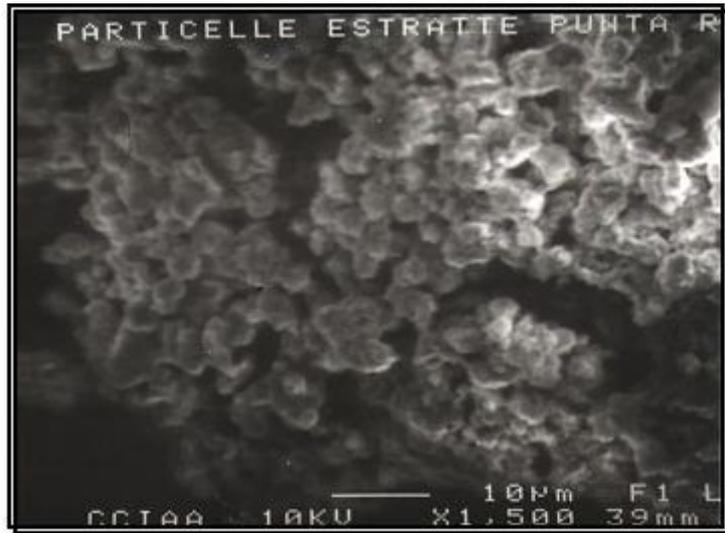
*Fotografia nr.5*

*Examination of the waxy clot found in the ink of the defective refill tip shown in Picture n. 4.*

*Please note the spherical crystalline structure of the examined mass particles.*

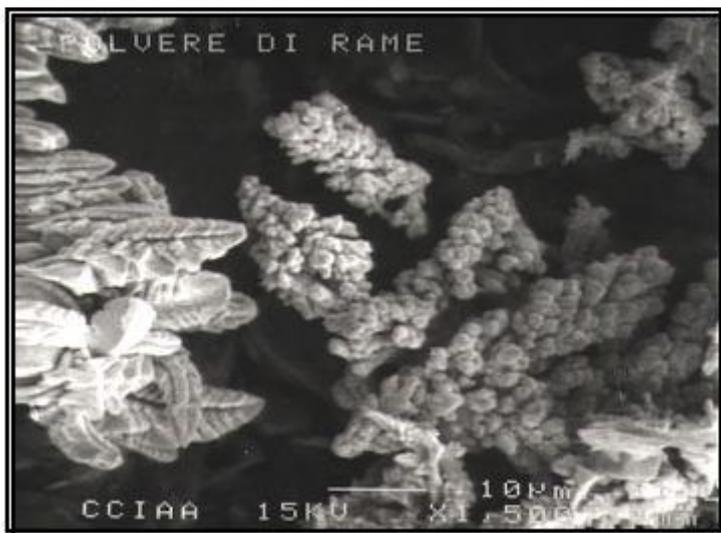
*Fotografia nr.6*

Then we started looking for the element with the same crystalline structure observed at the microscope. After the analysis of several pure particles and artificially created products, the optimal result was obtained using some brass powder (see Picture n. 6).

*The picture was taken from the screen of a scanning electron microscope using a magnification of 1.500x. Copper powder. Please note the spherical crystalline structure very similar to that shown in Picture n. 5.*

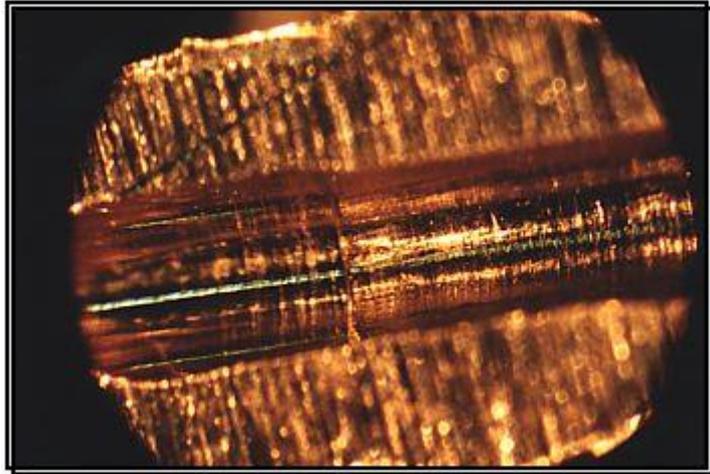
*Fotografia nr.7*

*Internal duct of a washed tip with no trace of corrosion.*

*Please note the clearliness and gloss of the internal duct.*

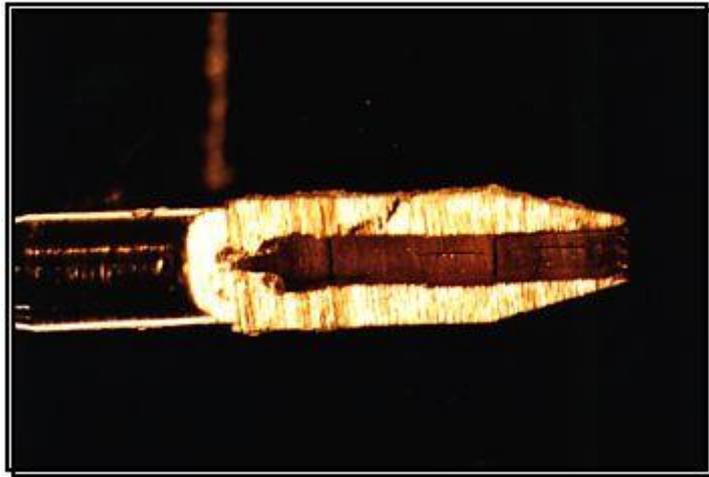
*Fotografia nr.8*

*Capillary duct where you can see the marked opaqueness of the wall, indicating that the acid etching has already started.*

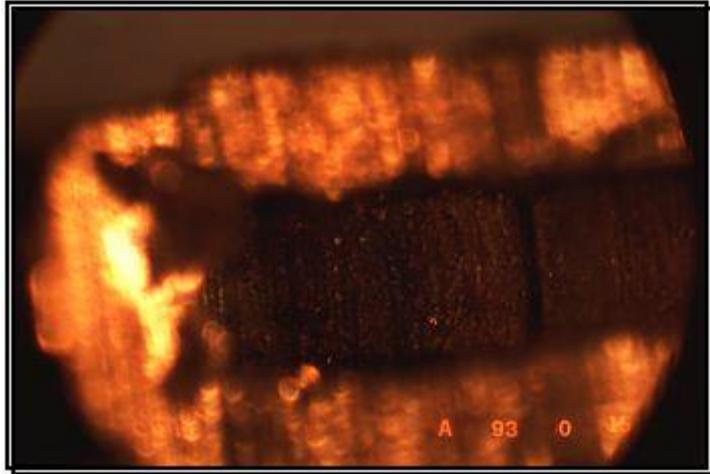
*Fotografia nr.9*

*Tip already observed in Picture n. 8 with a greater magnification.*

*Please note the whitish crystalline formation spreading all over the inner wall.*

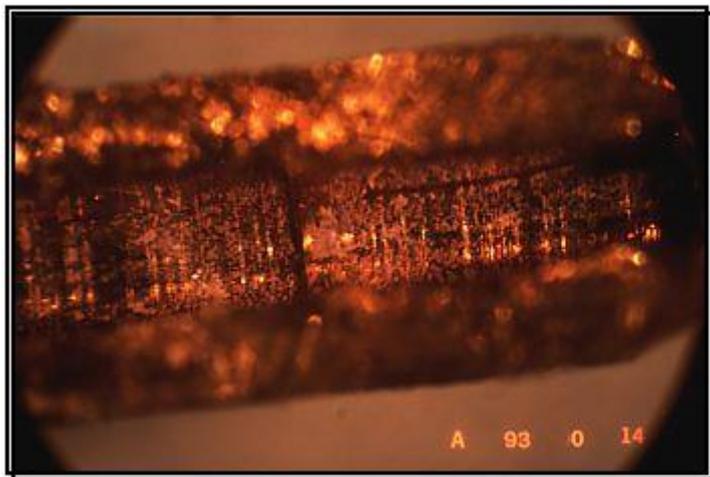
*Fotografia nr.10*

*Korean tip the inner duct of which is invaded by whitish crystals similar to those already observed on the outer wall of tips coming from the same production lot of refills shown in Picture n. 2.*

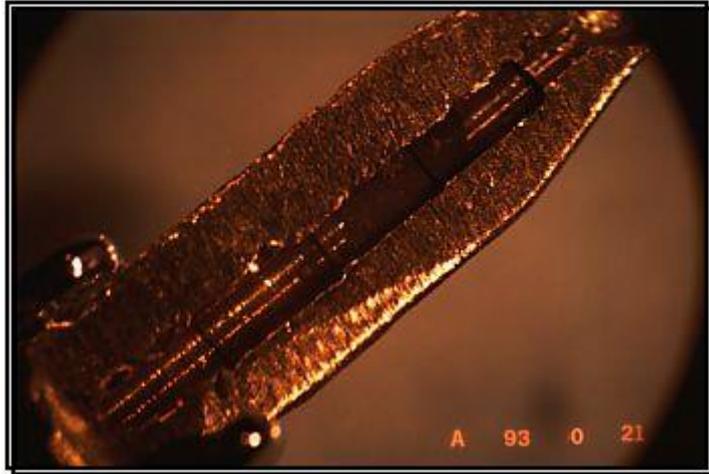
*Fotografia nr.11*

*Italian tip with a marked local etching probably due to the stagnation of a liquid drop inside.*

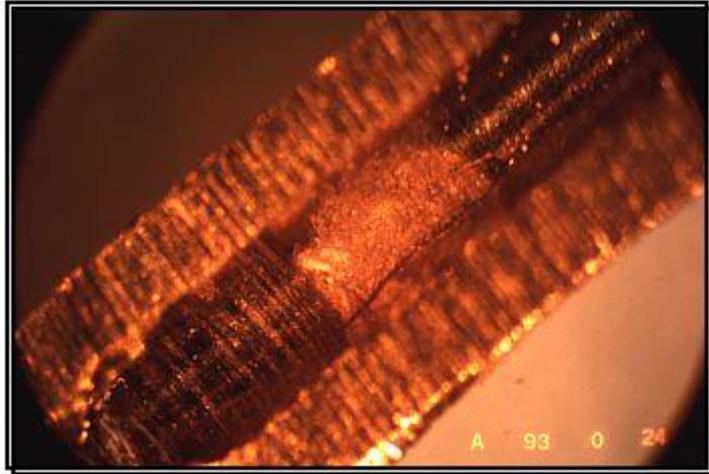
*Fotografia nr.12*

*Swiss tip with a marked local corrosion etching probably due to the stagnation of a liquid drop inside.*

*In this case a significant crystalline structure is to be observed.*

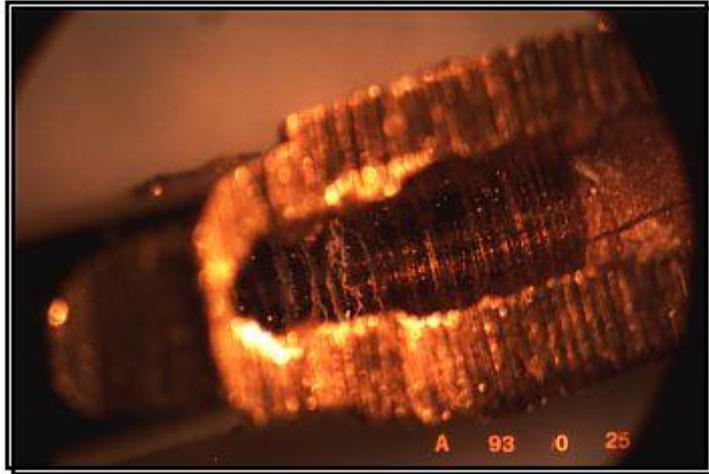
*Fotografia nr.13*

*Swiss tip already shown in Picture n. 12 at a greater magnification.*

*Please note the ring-like crystalline formations in the rear part of the inner duct.*

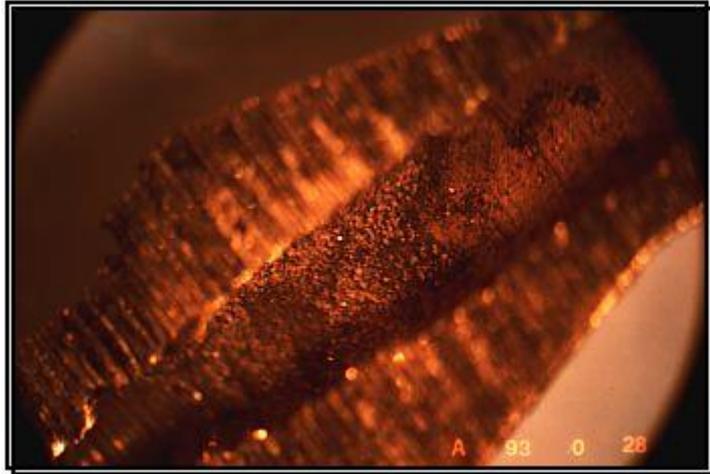
*Fotografia nr.14*

*The picture was taken from the screen of a stereomicroscope.  
Italian tip were corrosion widely affects the entire inner surface.*

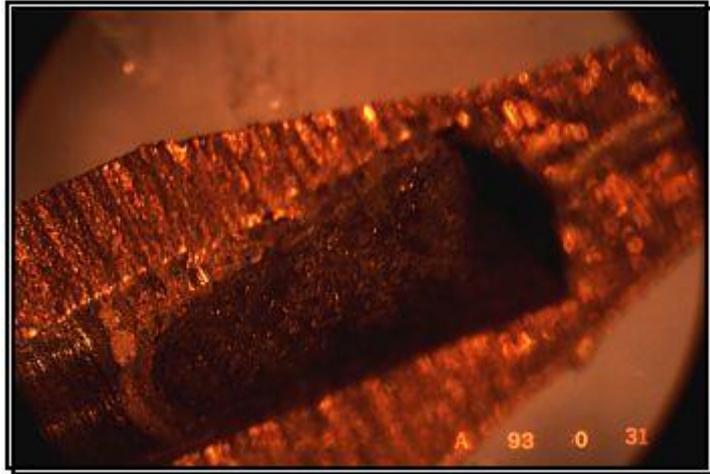
*Fotografia nr.15*

*Tip coming from Indonesia.*

*Please notice that the liquid stagnation near the duct behind the ball seat caused a significant saline corrosion.*

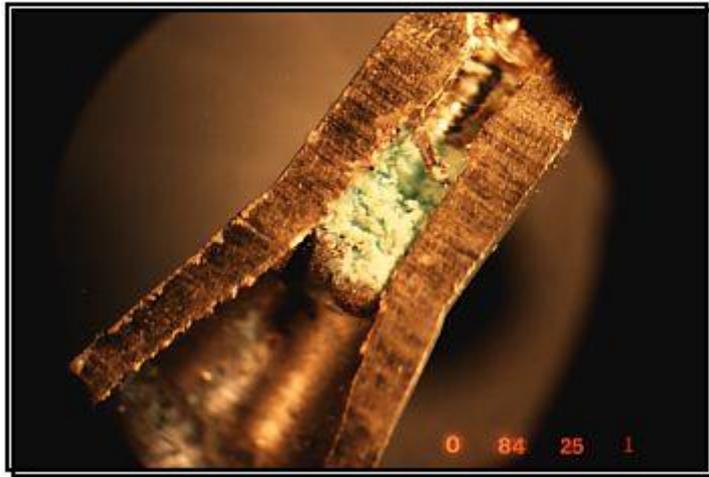
*Picture n. 16  
Reinol 0-84-25-1 Series  
The picture was taken from the screen of a stereomicroscope.  
Tip Nickel-plated at the end of the machining process.  
Example of acid corrosion due to the nickel-plating galvanic treatment.*

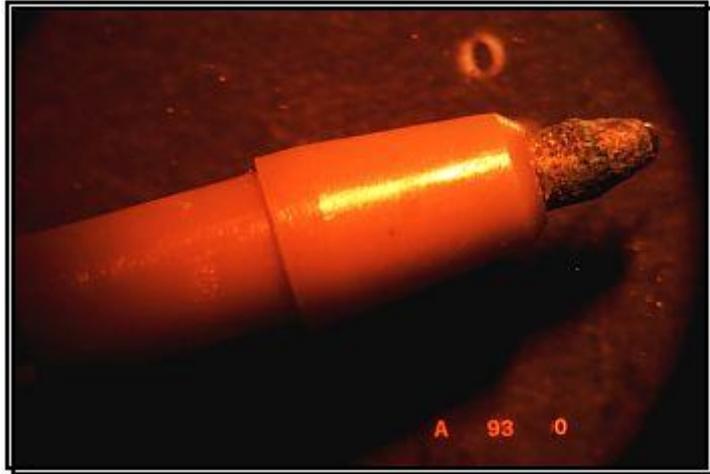
*Fotografia nr.17*

*Tip corroded by the acetic acid released by hydrolysis of acetalic resin (Delrin or Hostaform)*

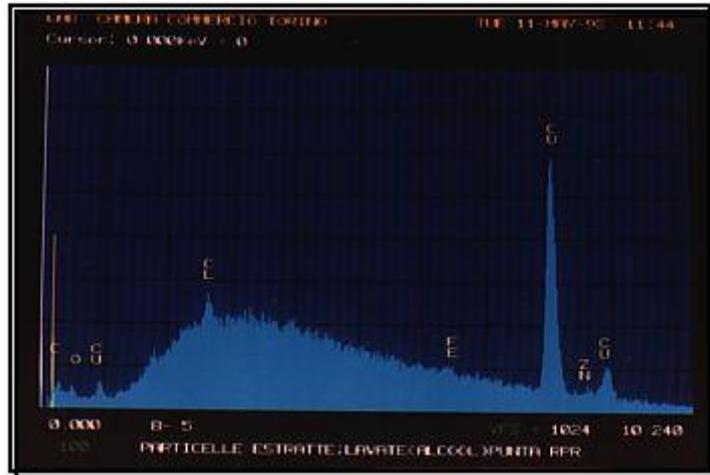
*Fotografia nr.18*

*Analysis of the waxy clot found in the ink of a defective refill tip shown in Picture n. 4 and 5. Please note the peaks of brass and chlorine components. Chlorine is neither part of brass nor of ink, it is therefore present as a pollutant.*

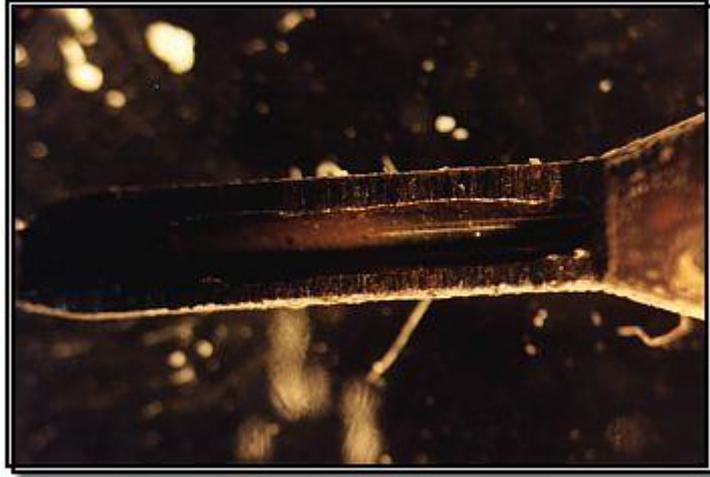
*Fotografia nr.19*

*Analysis of a new tip after dipping into a 0,1 N solution of hydrochloric acid. Please note the visible corrosion already started after a week from treatment.*

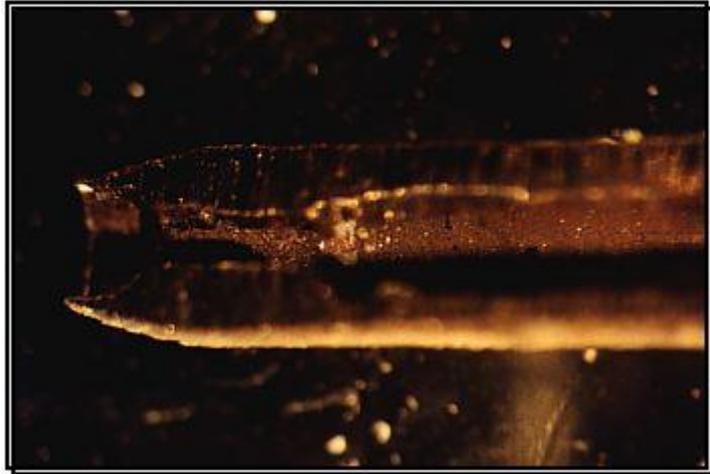
*Fotografia nr.20*

*Examination at a greater magnification of the front part of the tip shown in Picture n. 19.*

*In the area behind the ball you can notice the whitish efflorescence perfectly identical to those present in the tips of defective refills.*

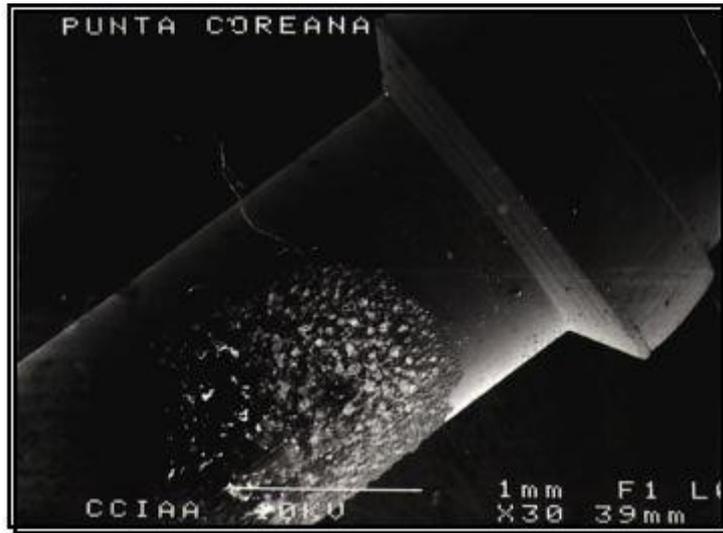
*Fotografia nr.21*

*Please note the saline efflorescence made more evident by the greater depth of field offered by the electronic microscope.*

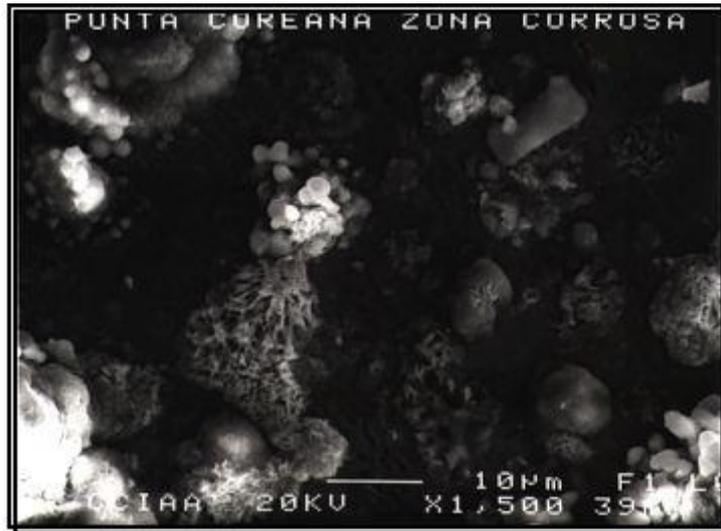
*Fotografia nr.22*

*Outer wall of a tip affected by a conspicuous corrosion shown in Picture n. 21.*

*There are clearly visible saline efflorescence made of lead (spongy structure) and Zinc (spherical structure) salts. The efflorescence visible in the background is made of Copper salts.*

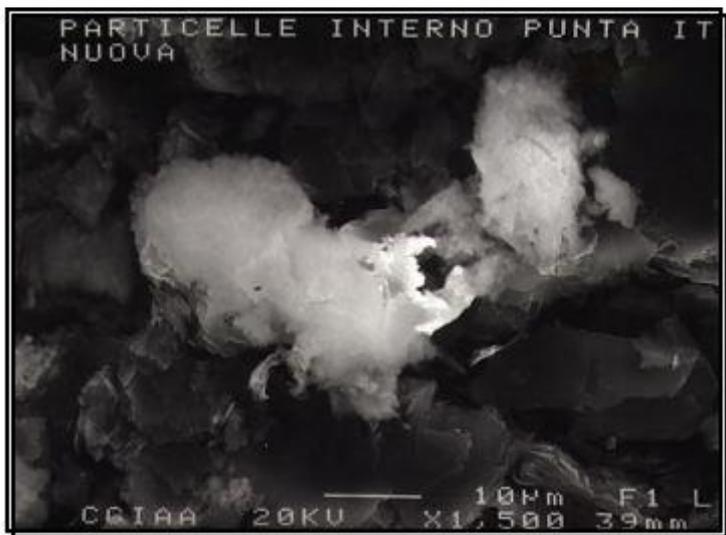
*Fotografia nr.23*

*The picture was taken from the screen of a scanning electron microscope using a 1.500x magnification. Particle extracted from a new recently produced tip made of Zinc salts (the dark flaky formations in the background represent the crystalline structure of the graphite conventionally used as base).*

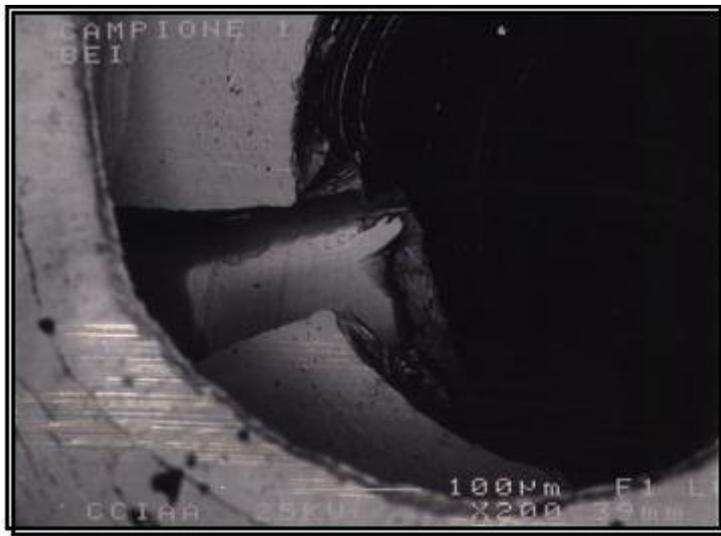
**Fotografia nr.25**

*The picture was taken from the screen of a scanning electron microscope with a x200 magnification. Ball seat of a tip taken from a defective refill holding competition ink. Please note the hollowness of the ink feeding duct and the slight pitting on the tip surface.*

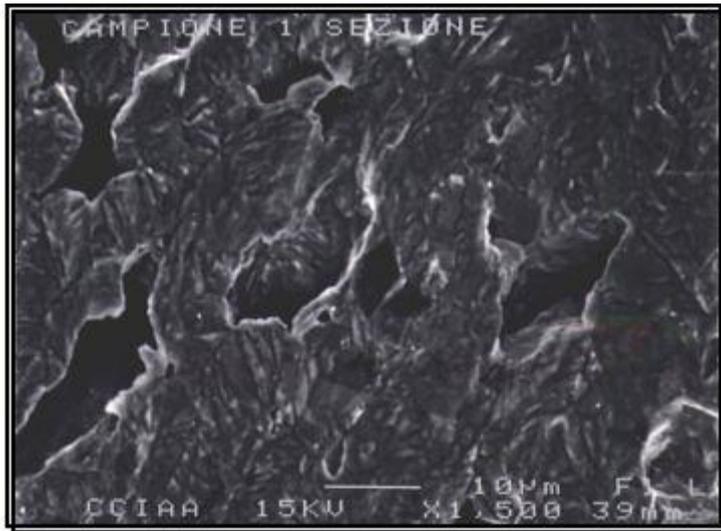
**Fotografia nr.26**

*The picture was taken from the screen of a scanning electron microscope with a x1.500 magnification. Inner wall of a tip taken from a defective refill holding competition ink. Here you can see how corrosion totally altered the metal structure.*

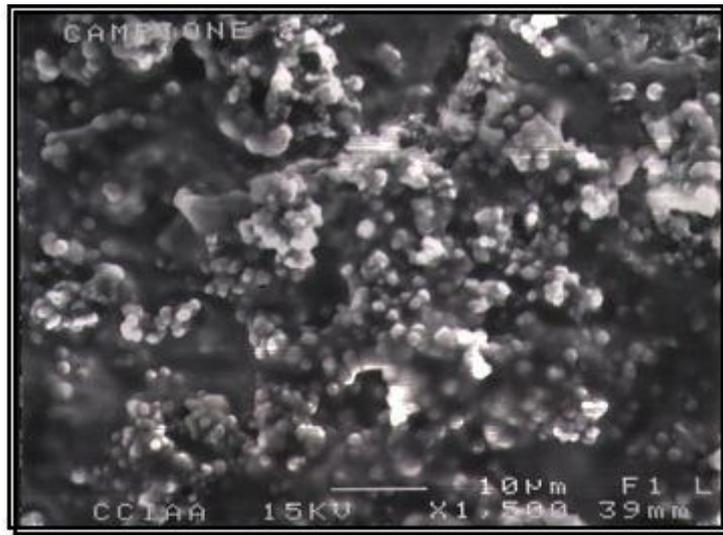
**Fotografia nr.27**

*The picture was taken from the screen of a scanning electron microscope with a x1.500 magnification.  
Analysis of the waxy clot produced by the artificial contamination of ink with copper chloride.*

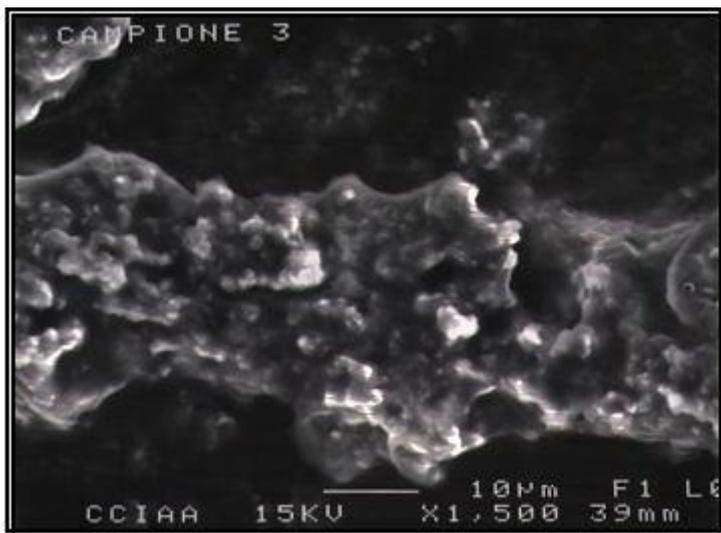
**Fotografia nr.28**

*The picture was taken from the screen of a scanning electron microscope with a x1.500 magnification.  
Analysis of the waxy clot produced by the artificial contamination of ink with zinc chloride.*

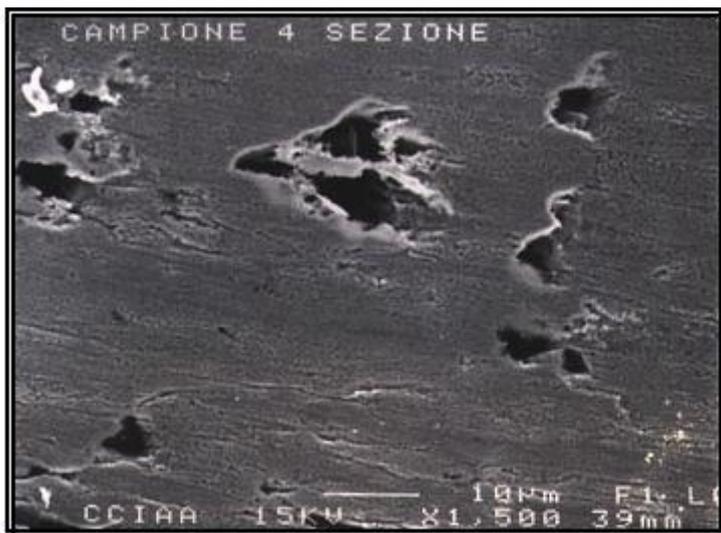
**Fotografia nr.29**

*The picture was taken from the screen of a scanning electron microscope with a x1.500 magnification. Inner wall of a tip removed from a defective refill with Reinol ink. Please compare this picture with picture n. 26 and note the smaller hollowness (though present) and the complete absence of pitting.*

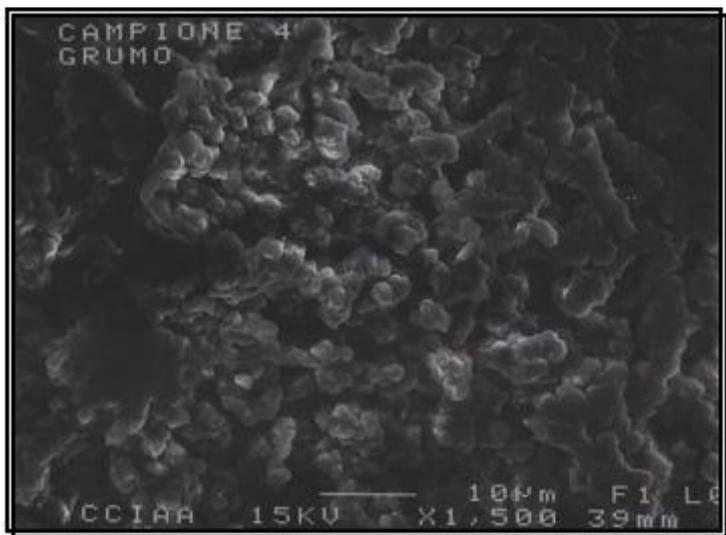
**Fotografia nr.30**

*The picture was taken from the screen of a scanning electron microscope with a x1.500 magnification.  
Analysis of the waxy clot of ink held in the tip of a defective refill shown in Picture n. 29.  
Please note the spherical crystalline structure of the mass particles.*

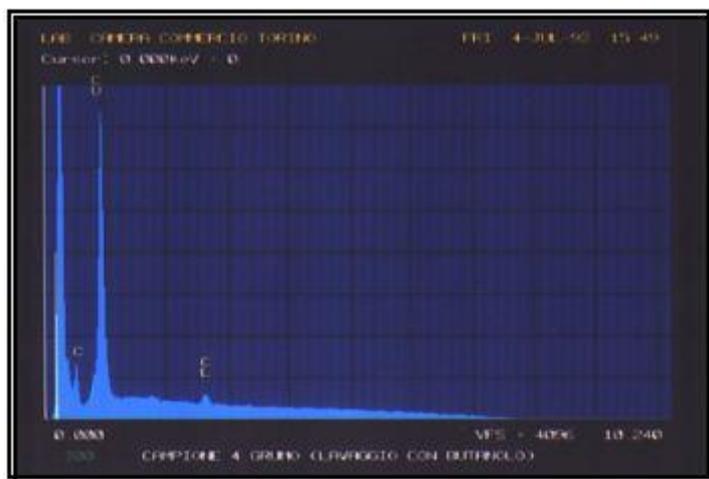
**Fotografia nr.31**

*Analysis of the waxy clot of ink held in the tip of a defective refill shown in Pictures n.29 and 30. Please note the copper and chlorine peaks.*

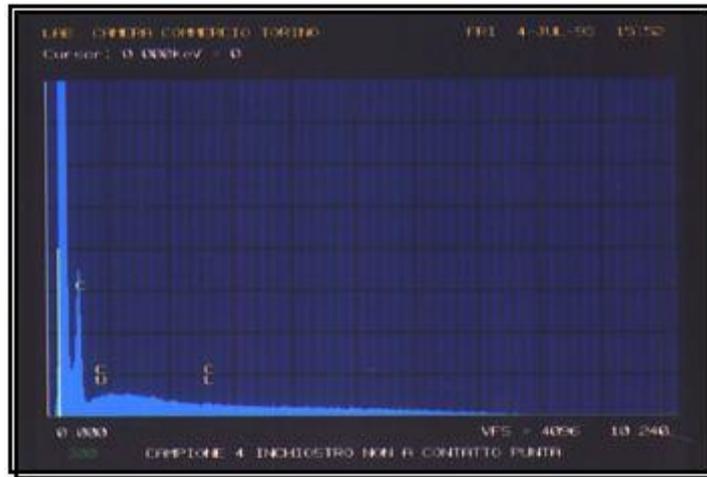
**Fotografia nr.32**

*Analysis of the waxy clot of ink held in the tip of a defective refill and taken from an area not in contact with the tip. In this case copper and chlorine peaks are absent (see picture n.31), meaning they do not stem from the ink.*

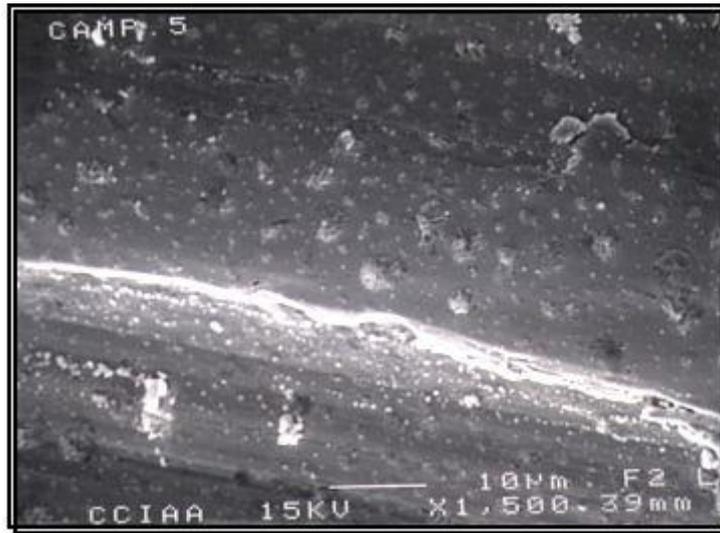
**Fotografia nr.33**

*The picture was taken from the screen of a scanning electron microscope with a x1.500 magnification. Inner wall of a new tip where corrosion due to acid etching has been reproduced following the description previously mentioned.*

*Please note the evident whitish saline efflorescence subsequently removed from the ink and causing the well-known hollow formations.*

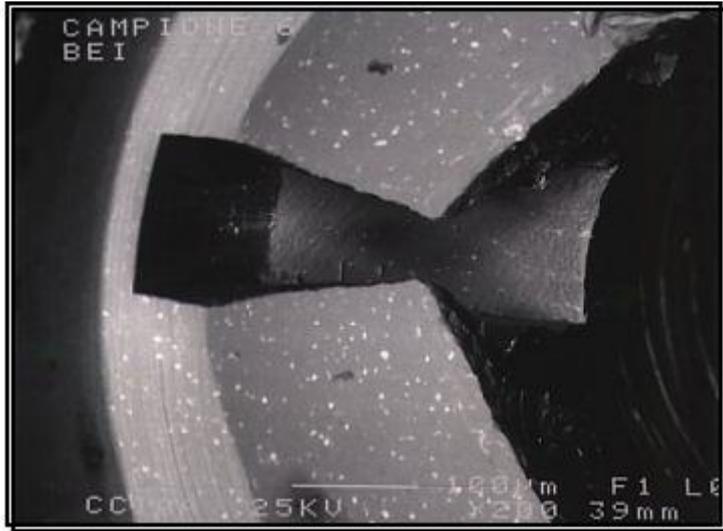
**Fotografia nr.34**

The picture was taken from the screen of a scanning electron microscope with a x200 magnification. Ball seat of a tip picked from a defect-free lot. Please note the complete absence of hollowness due to corrosion.

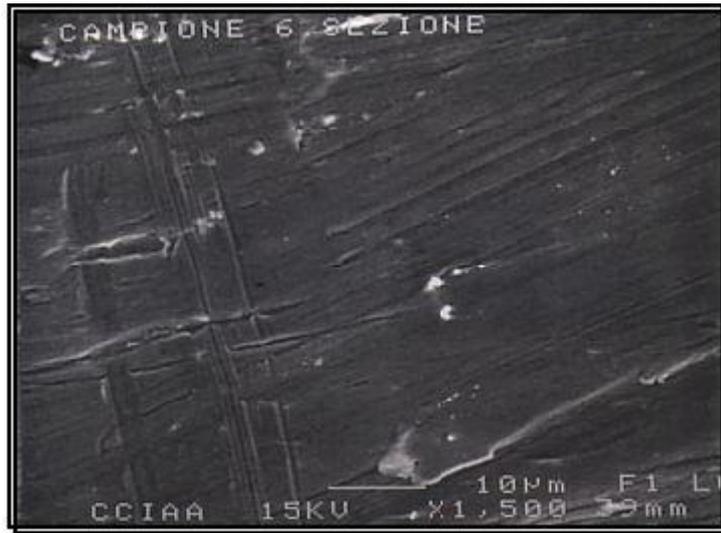
**Fotografia nr.35**

*The picture was taken from the screen of a scanning electron microscope with a x1.500 magnification. Inner wall of a non corroded tip picked from a defect-free lot. The sample shows rare sites of corrosion.*

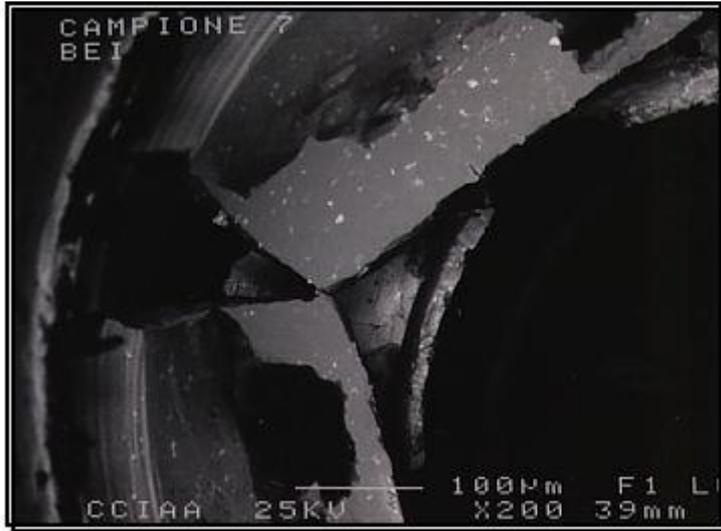
**Fotografia nr.36**

*The picture was taken from the screen of a scanning electron microscope with a x200 magnification. Ball seat of a new X-10 tip picked from a defective lot. Please note the unevenness of inner surfaces due to an advanced corrosion stage.*
