UTILIZZAZIONE DEI SOLVENTI CLORURATI COME AGENTI DI LAVAGGIO NELL'INDUSTRIA METALMECCANICA ED IN PARTICOLARE NELLA PRODUZIONE DELLE PUNTE IN OTTONE PER ARTICOLI SCRIVENTI

THE USE OF CHLORINATED SOLVENTS AS WASHING AGENTS IN THE METAL AND STEEL INDUSTRIES, AND PARTICULARLY IN THE PRODUCTION OF BRASS POINTS FOR WRITING INSTRUMENTS, WITH ASSOCIATED PROBLEMS

Massimo Gippa  
Pietro Buzzetti

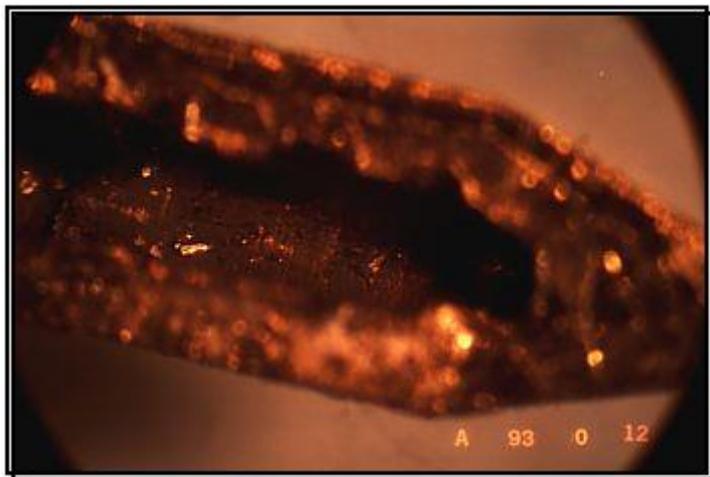
*Fotografia nr.24*

*The picture was taken from the screen of a scanning electron microscope using a 1.500x magnification. Particle extracted from a new recently produced tip made of Zinc salts (the dark flaky formations in the background represent the crystalline structure of the graphite conventionally used as base).*

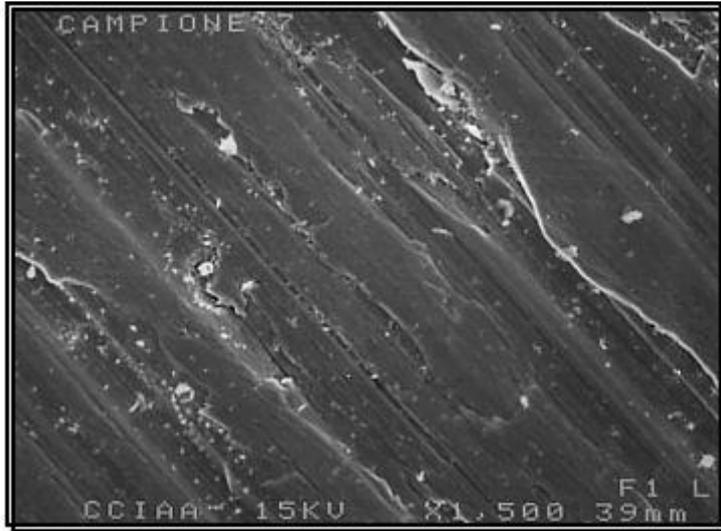
**Fotografia nr.37**

*The picture was taken from the screen of a scanning electron microscope with a x200 magnification. Ball seat of a new X-10 tip picked from a defective lot. Please note the unevenness of inner surfaces due to an advanced corrosion stage.*
